Flood Control using the Automation Tops Spillway Gates: A case study of the Avis Dam, Namibia

P.D. TOWNSHEND, Flowgate Projects (Pty) Ltd, RSA
K.A. LUND, Lund Consulting Engineers, Namibia

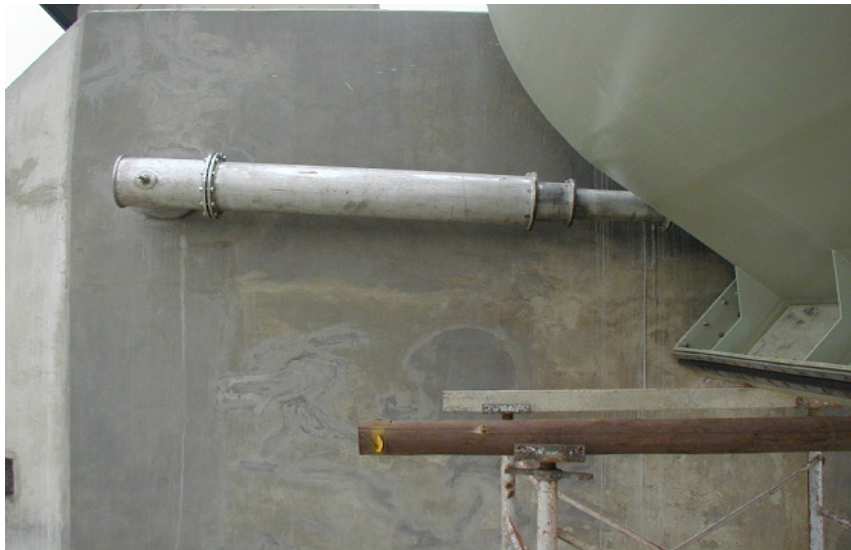
Telescopic arm connecting the ballast tank to the float controlled valve.

For these particular TOPS gates, a telescopic arm connects the ballast tank to a float controlled discharge valve. When the water level rises above 300mm over the gate, the discharge valve will open automatically to release water from the ballast tank thereby reducing the closing moment which then causes the gate to open.

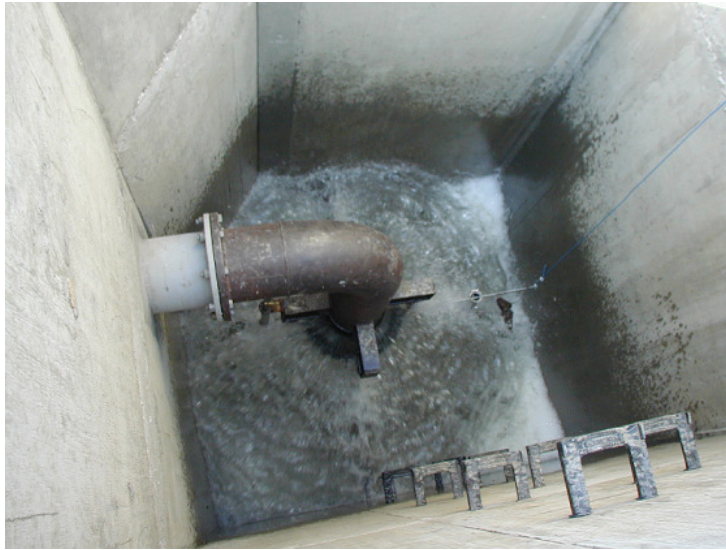
Float controlled discharge valve discharging water from the ballast tank

As the water level in the dam drops as a result of the discharge through the gates, the discharge valve closes automatically, water flows into the ballast tank through the 4 openings to the dam to add mass to the ballast tank thereby causing the gate to close.

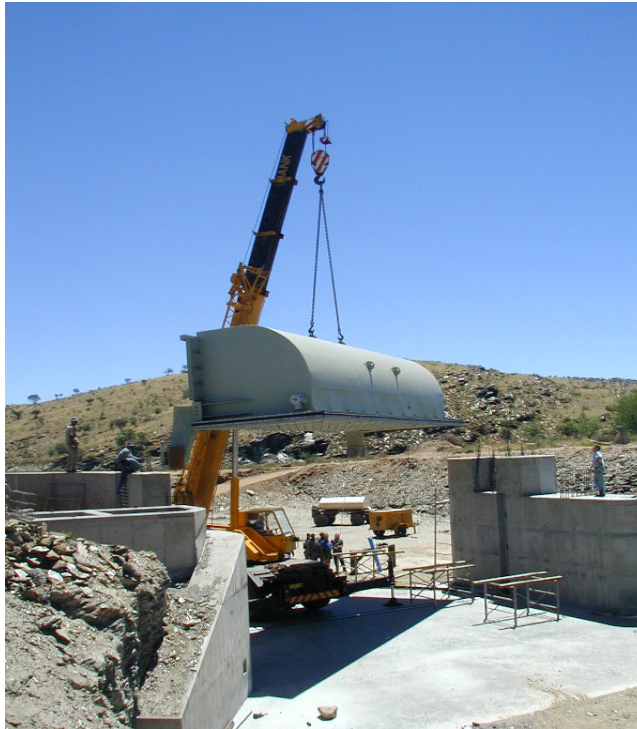
Gate lifted complete into position

The gates were then lifted into position by a 35 tonne crane and placed over holding down bolts to locate and secure the trunnion brackets.

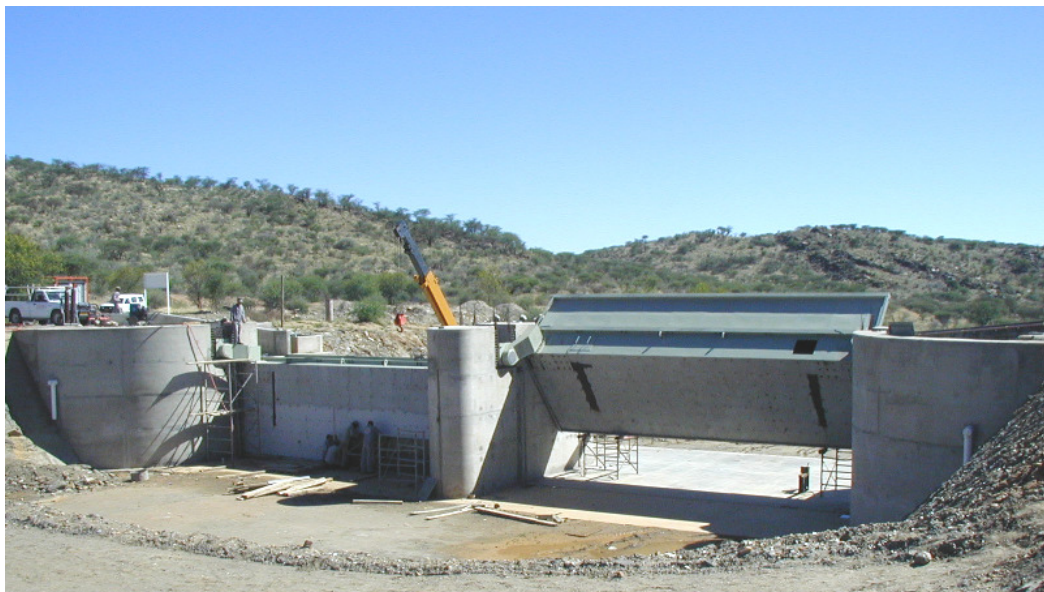
Gates installed ,one partially open

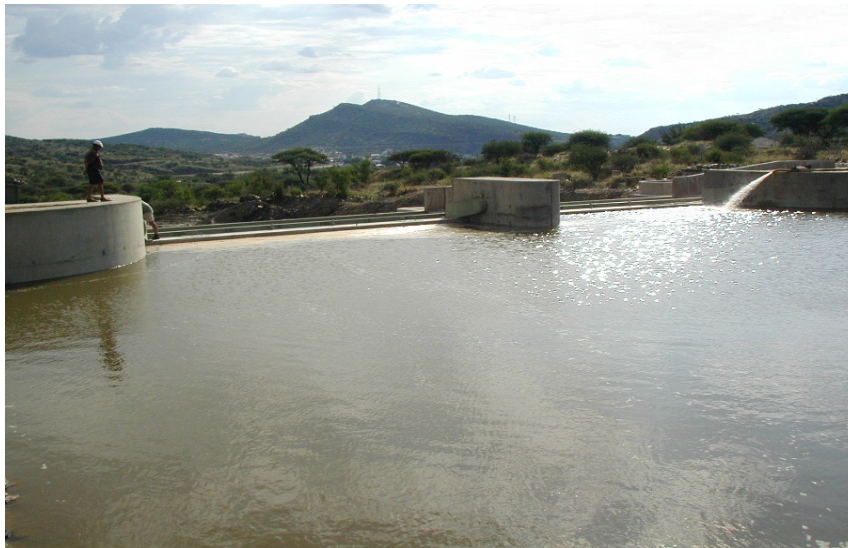
Gates retaining full 3,5m water

An earth coffer dam was constructed 20m upstream and water then pumped in behind the gates over two days to reach the final depth of 3,5m above sill level. The gates did not show any sign of distress.

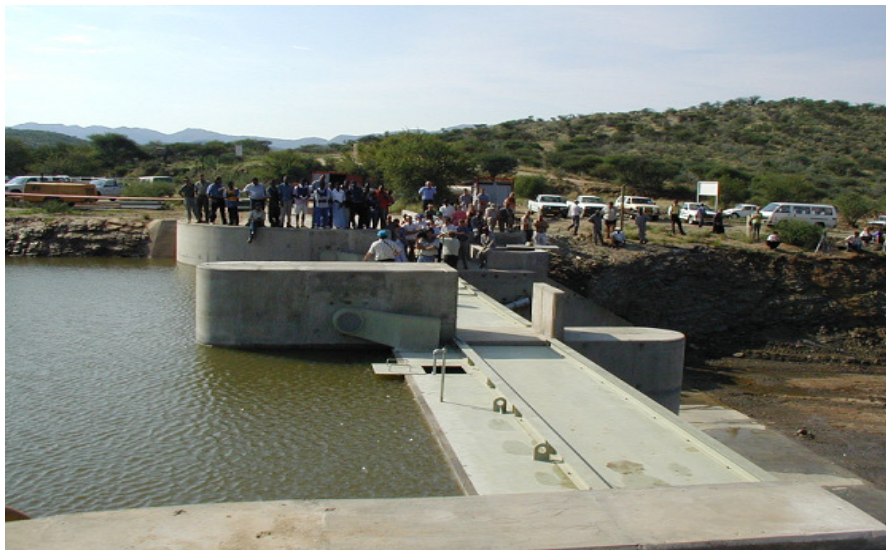
Gates ready for wet commissioning

The various components such as the level control discharge valve and the manual butterfly valve were wet tested.

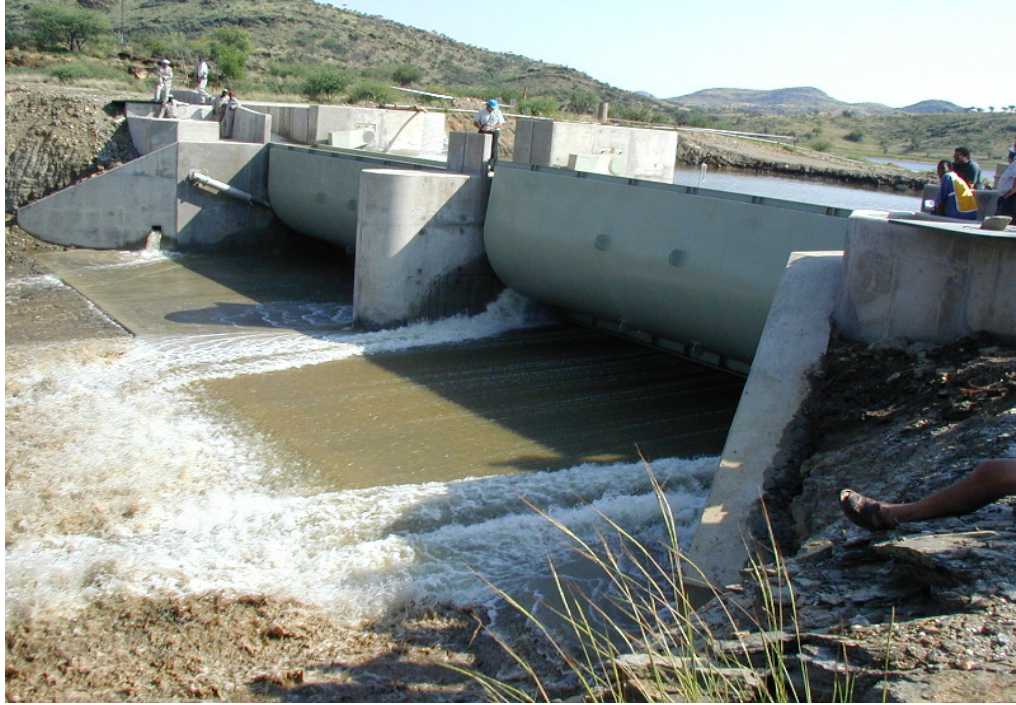
One gate opening

With 60 interested observers and dignitaries in attendance the float controlled valve and manual valves were opened to release water from the ballast tank. At a drop of water level in the order 0,9m in the ballast tank, one gate opened and then the other.

Unfortunately here was insufficient volume of water behind the gates to maintain an almost constant water level which is required to open the gates fully. The first gate opened partially which rapidly drew the water level down behind the gates so that full opening could not be achieved.
